# Saw Mill River and Hudson River Stakeholder Review of 2023

# **(The Distinguished River):** A section of our newsletter dedicated to the great ever changing rivers

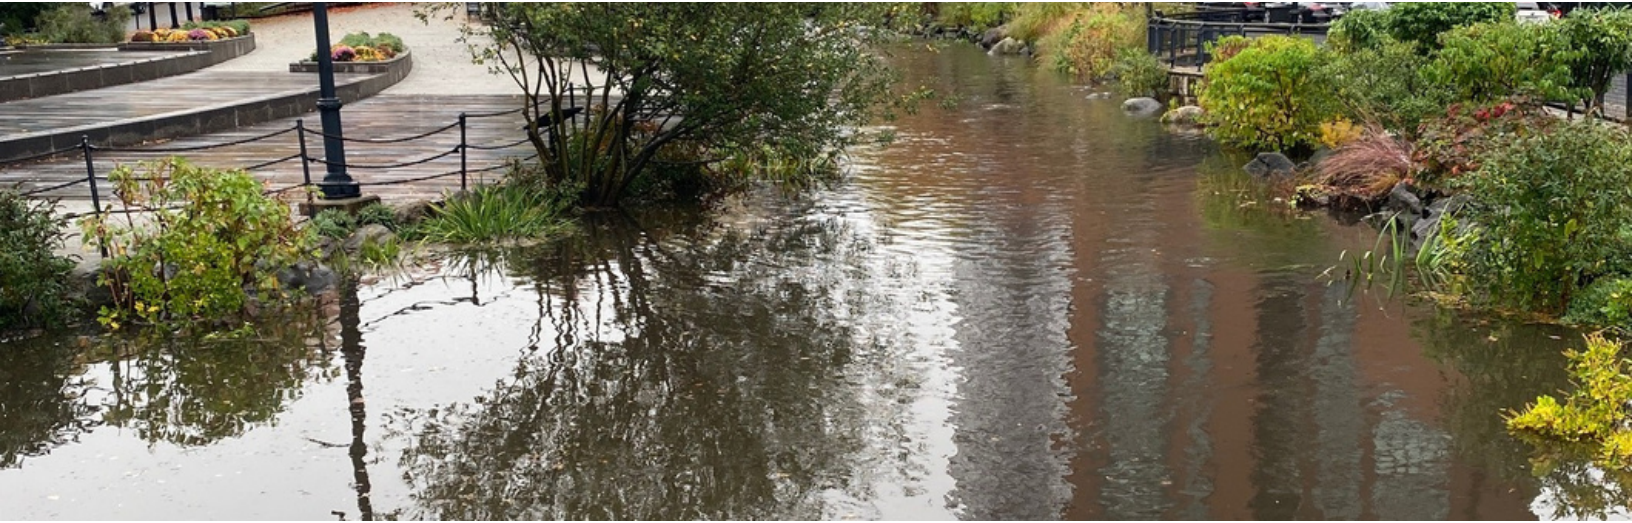
The above photo captures the daylighted segment of the Saw Mill River at Van Der Donck park in downtown Yonkers on the morning of October 30th, 2023. If you take a quick glance, this photo looks of a serene river passing through a metropolitan area. If you trace your line of sight along the edges, you will notice that the river banks are completely engulfed with water. The buffer zone of the river banks are almost non-existent - doing an excellent job of "controlling" the flooding and preventing it from impacting areas of the park dedicated to recreation use. This excessive flooding is the result of 0.94" of rainfall along the southern parts of the Saw Mill River watershed. In natural riverine systems, most rain would be absorbed by natural spaces surrounding the river and prevent a lot of excessive flooding as seen above. The current spaces along the Saw Mill River have been altered for the convenience of human use - including industrial, commercial, and residential. The development along what is considered the Saw Mill River floodplain has left the river system with very few permeable surfaces - fast tracking a lot of the said rainwater directly into the mainstem river.

Excessive rain and a myriad of other technical issues/ailing infrastructure cause a runaway downward spiral, ultimately impacting water quality conditions. On a basic level, this is impacting species that consider the waterway a habitable location. On a broader level, this is impacting communities that are interacting with this waterway in one way, shape or form.
